Iconic Book Buildings Get a New Cover

A "By the Book" Restoration of a
Detroit Landmark

RAM Construction Services: Iconic Book Buildings Get a New Cover

A “BY THE BOOK” RESTORATION OF A DETROIT LANDMARK

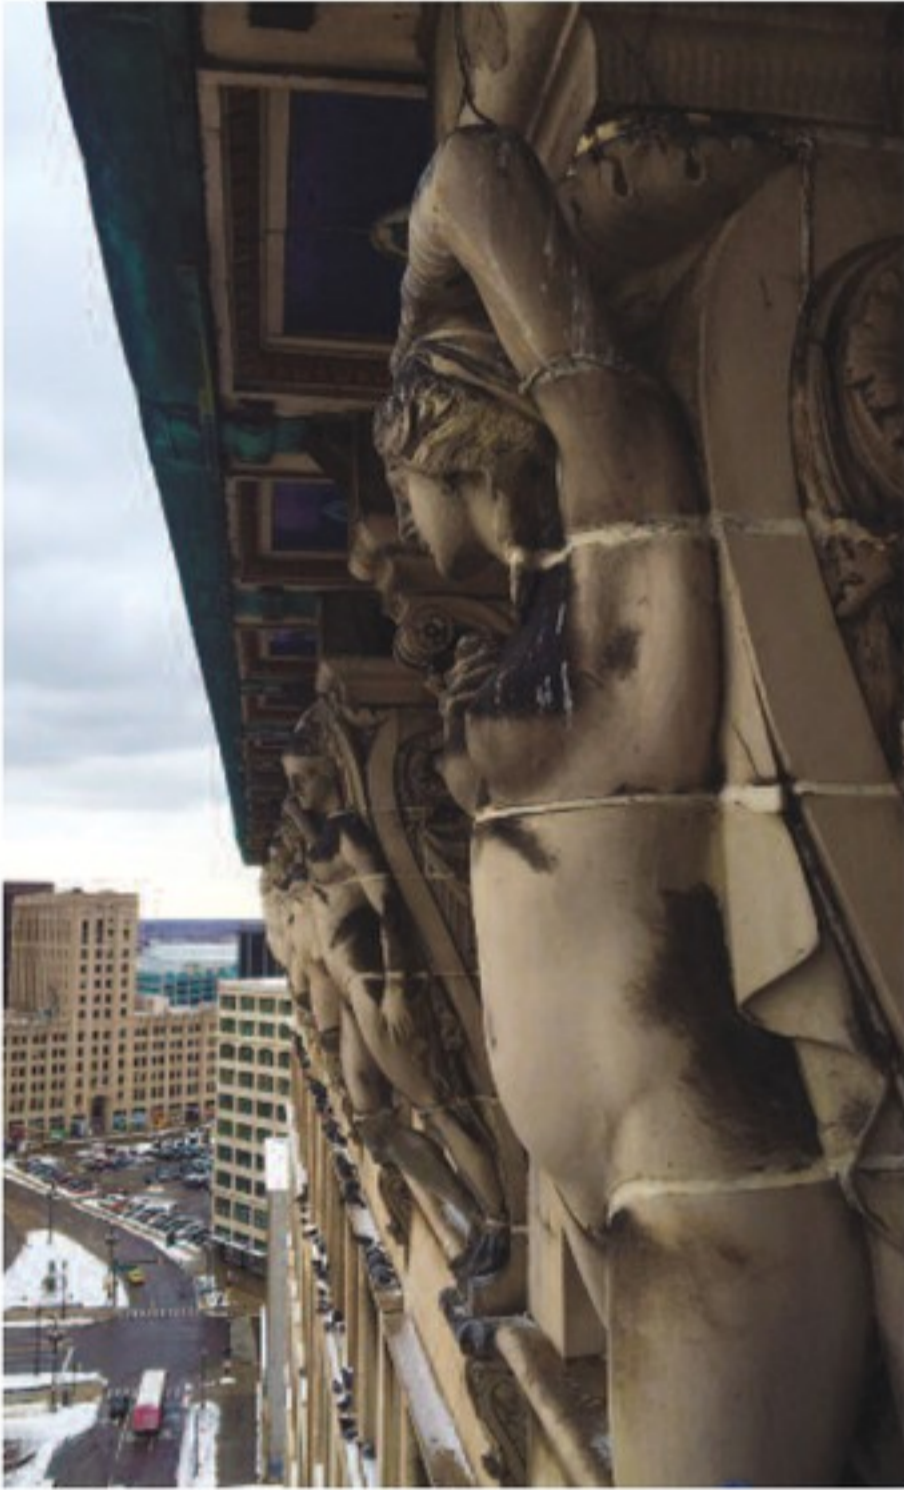
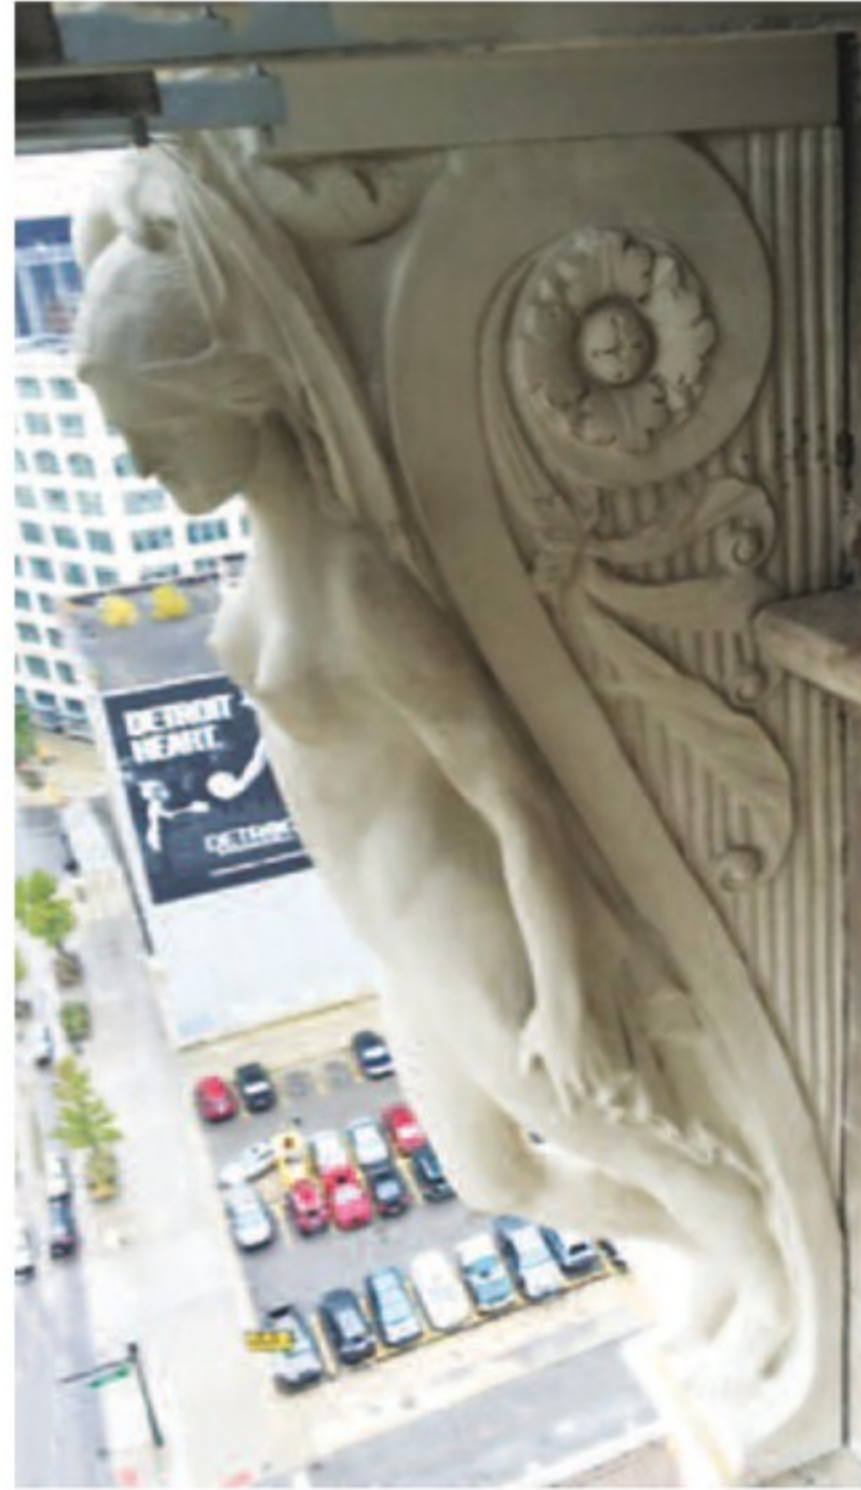
Left/Middle: Removed in 2016, the damaged terra-cotta sculptures had been architecturally supporting the cornice of the Book Building, circa 1917, for just under a hundred years. Each of the 13-foot-tall female sculptures, called caryatids, is now replicated in fiberglass.

In 2016, RAM Construction Services removed each 13-foot-tall caryatid in pieces and reassembled two of the sculptures in their entirety, one for the maidens supporting the cornice with their right arms and another for those supporting the cornice with their left arms. Glassline, Inc., Plymouth, fabricated molds for the replication of all 12 caryatids in

glass fiber reinforced polymer (GFRP), or simply fiberglass. Today, these muses of the building arts once again grace this Italian Renaissance structure designed by famed Detroit architect Louis Kamper.
