# CAM

Michigan State Capitol  
Roofing Renovation

# CASS PROVES ITS METTLE AT THE MICHIGAN STATE CAPITOL

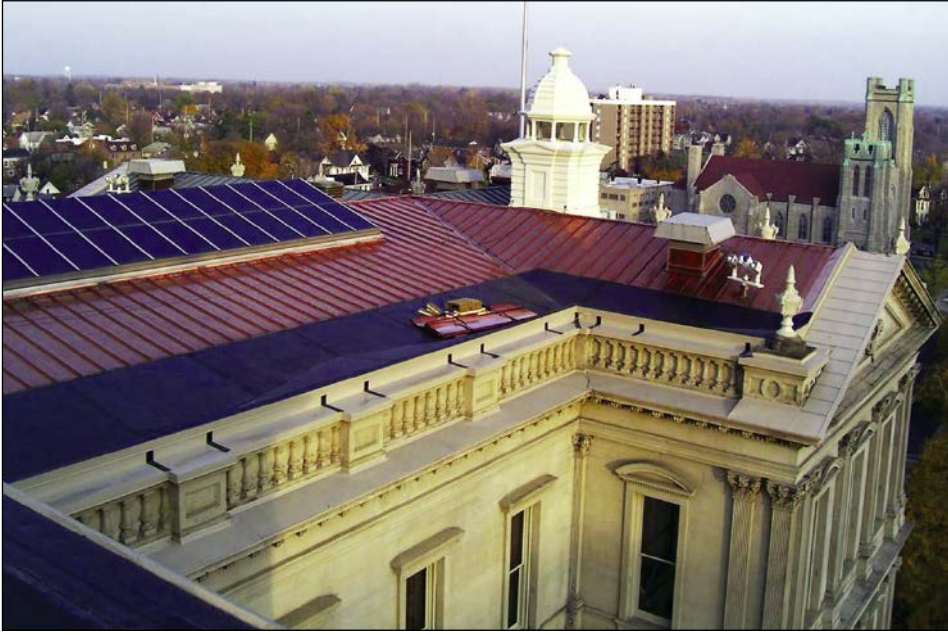
PHOTO BY GEORGE DEGORSKI

**The sun's glow brightens the copper rooftop of Michigan's Capitol. The overall roofing plan called for installation of a new copper batten seam double lock system installed up to the ridge and a 90 mil, fully adhered Firestone EPDM roof on primed Dens deck in the valleys.**

CASS meticulously sealed the roof, making every detail water-tight in all weather conditions. The overall roofing plan called for installation of a new copper batten seam double lock system installed up to the ridge and a 90 mil, fully adhered Firestone EPDM roof on primed Dens deck in the valleys. "This is a long-lasting rubber roofing system with 30-year type details," said Parvin.

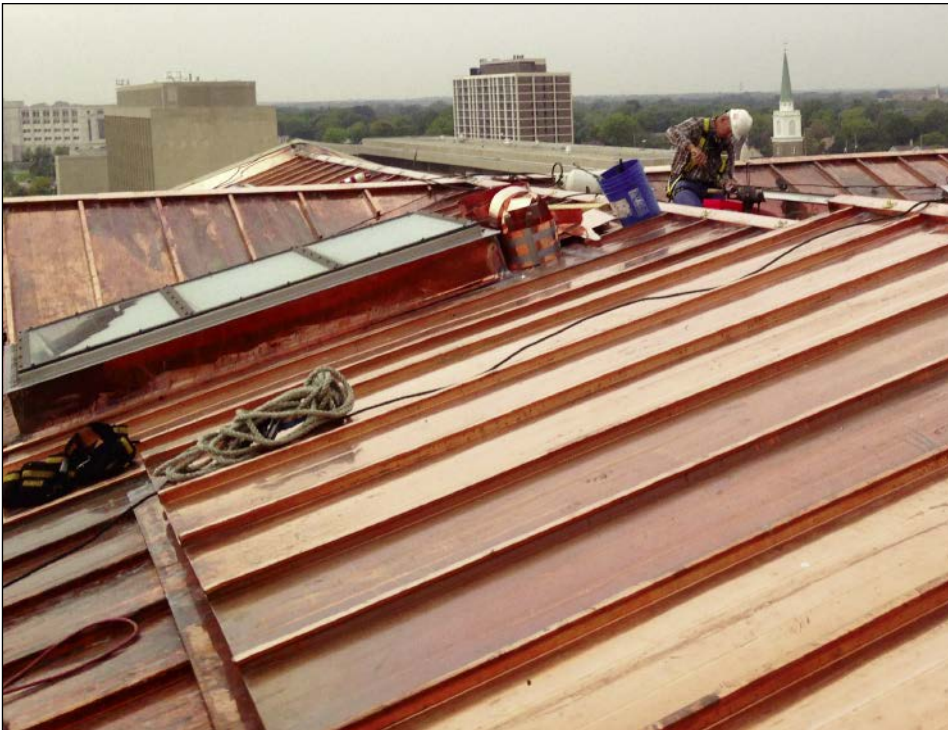
**The craftsmen of CASS Sheet Metal are busy at what they do best: Paying meticulous attention to every roofing detail, a work ethic of special importance when working on a national historic landmark that serves as Michigan's official seat of government.**

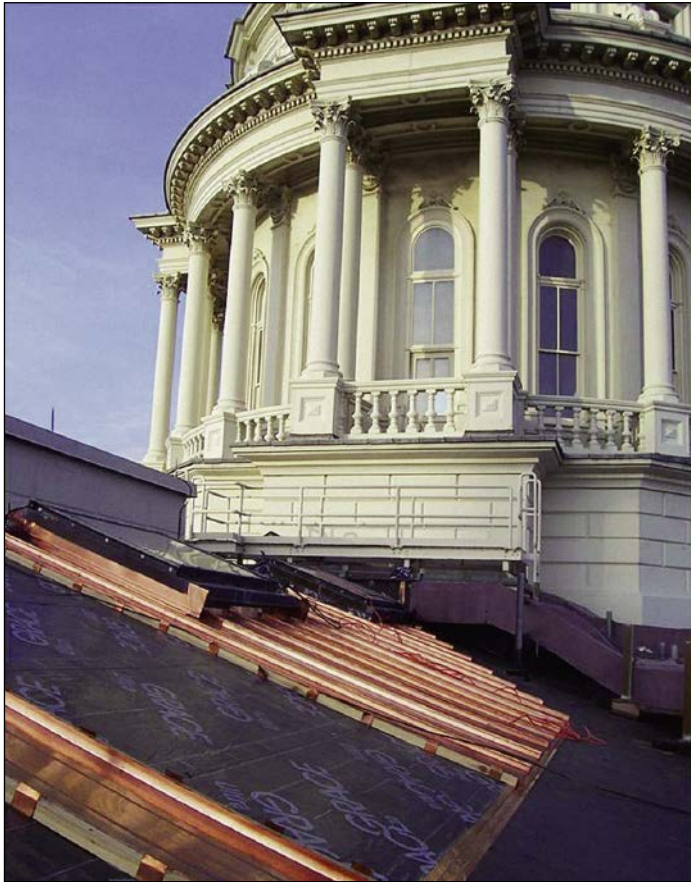
PHOTO BY GEORGE DEGORSKI

**Roof renovation of the Michigan Capitol included work not only on the gently sloping main roof, but also on the flat roofs adorning the drum of this elegant dome.**

arc of the actual dome is perched on this grand podium that features three levels of flat roofs: Two different levels of walkable ledges ring the dome, the first ringed in a lovely colonnade of columns and a balustrade; the second featuring another ornate balustrade; and the third and highest being only a small “eyebrow” of a ledge.

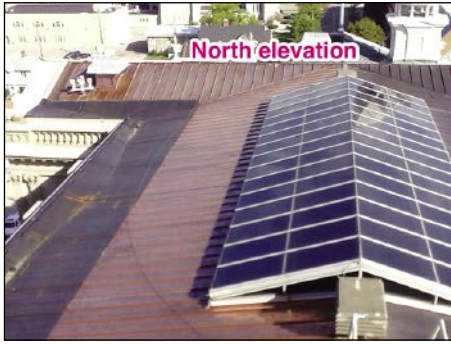
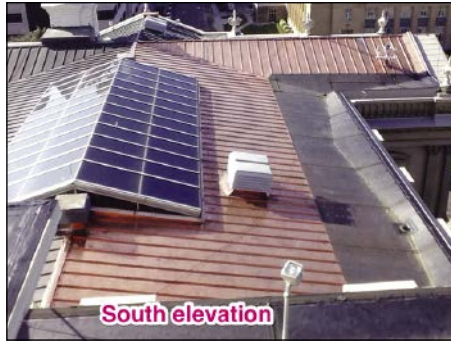
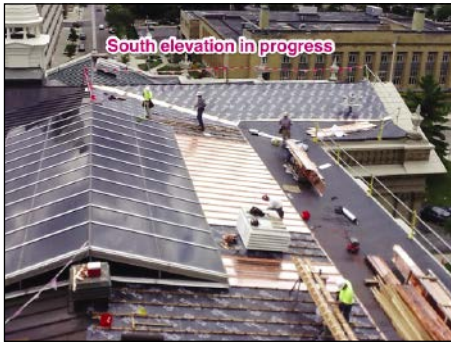
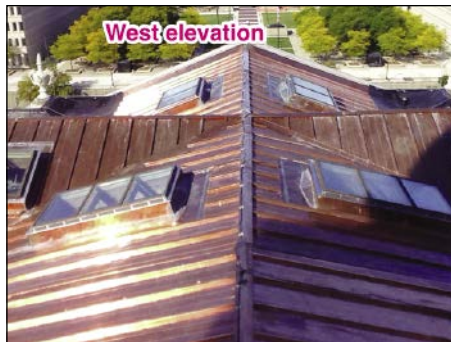
The work of CASS Sheet Metal and Bloom Roofing Systems is displayed in all its glory in this multi-directional panorama of copper and heavy-gauge rubber roofing.

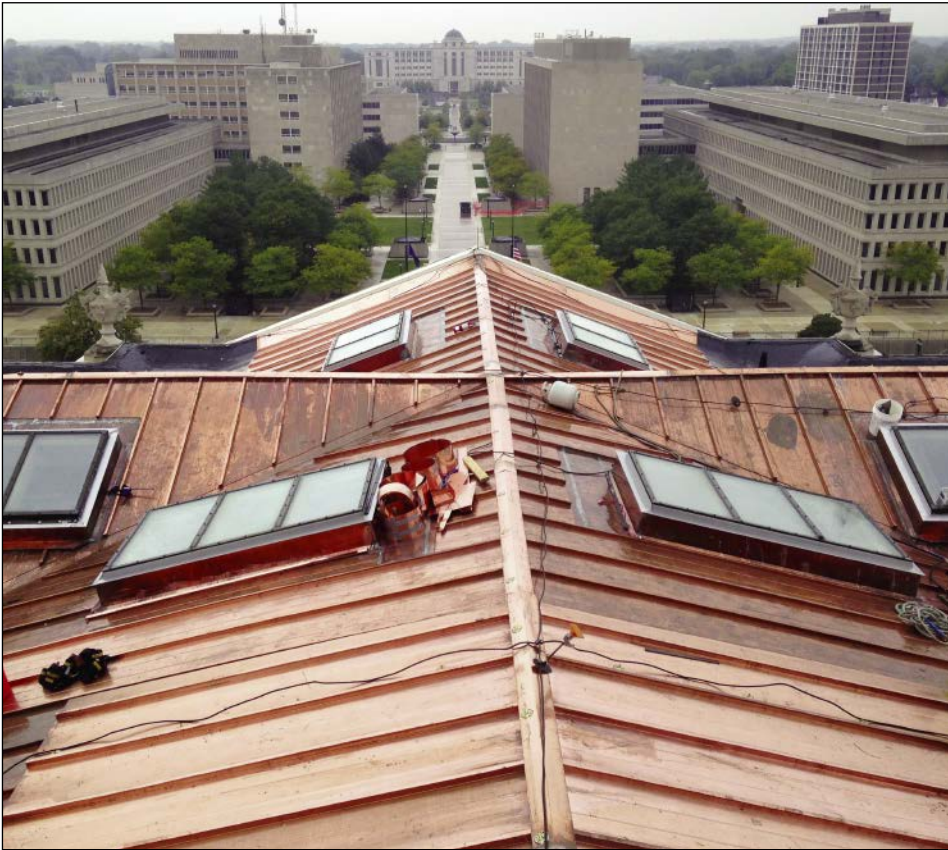
In replacing and installing the Capitol's copper roof, CASS Sheet Metal followed the recommendations of the well-regarded technical manuals: the *SMACNA Architectural Sheet Metal Manual* and a manufacturer's publication called *Revere's Copper and Common Sense*.

As part of the new test plan, CASS Sheet Metal religiously followed the recommendations of the two principal technical manuals in the historical architectural sheet metal and copper trade - *SMACNA Architectural Sheet Metal Manual* and a manufacturer's publication called *Revere's Copper and Common Sense*. These trusted sources recommend the application of a traditional double-lock batten cap system on low-slope roofs. With only a 3:12 pitch, the Capitol roof is considered to be gently sloping. The roof, however, had a snap-on batten versus the recommended double-lock batten seam roof that was actually the original roof detail, according to Parvin.

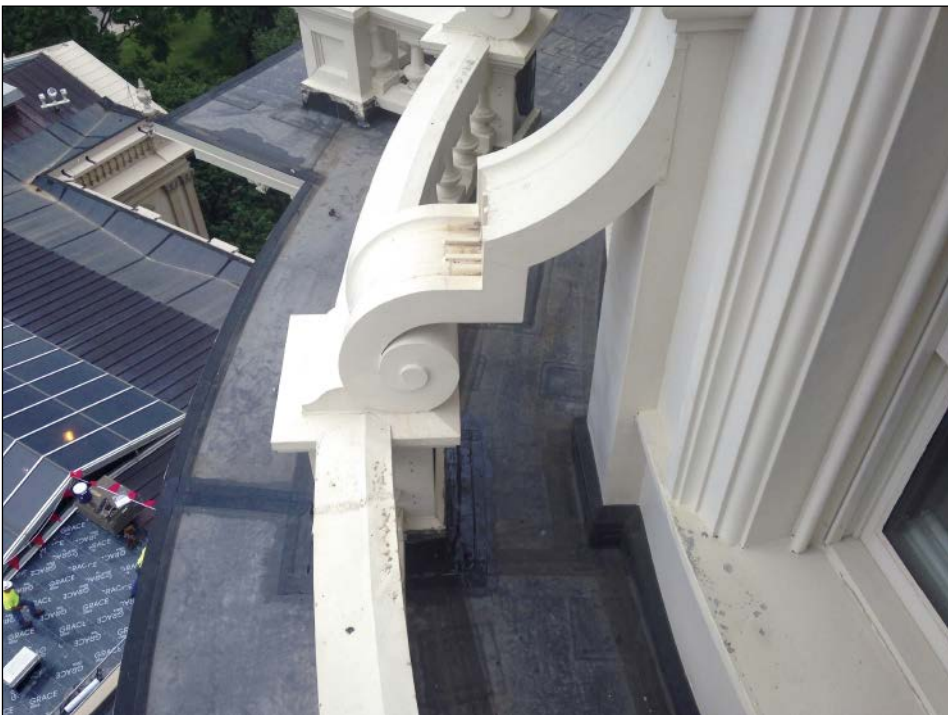
Elegance restored: CASS and Bloom replaced the lead pan roofs on two flat levels of the Capitol dome's drum with a 90 mil Firestone EPDM fully adhered rubber roofing system with 90 mil flashings.

CASS and Bloom replaced the lead pan roofs on two levels with a 90 mil Firestone EPDM fully adhered rubber roofing system with 90 mil flashings and walkway pads. “The old system was a lead pan of approximately 3 lbs.,” said Parvin. “The sealant gradually aged, creating problems at the joints and making the system susceptible to water infiltration.”

In addition, the sheet metal trapped water. “The sheet lead was very thick, and it had deep metal folds that created water-trapping ridges,” said Tyler. “Ultimately, the caulk sealing the lead sheets was starting to fail.”
