Up in the air

Two years ago, Cass Sheet Metal began the exterior copper restoration on Detroit's 500-foot tall Book Tower building, an iconic and historic centerpiece in the city's downtown skyline built in 1926. As the sun set on the restoration and the project came to a close this year, SNIPS recently paid the job site a visit to capture the crew working up in the air during magic hour; and what we saw was nothing less than.

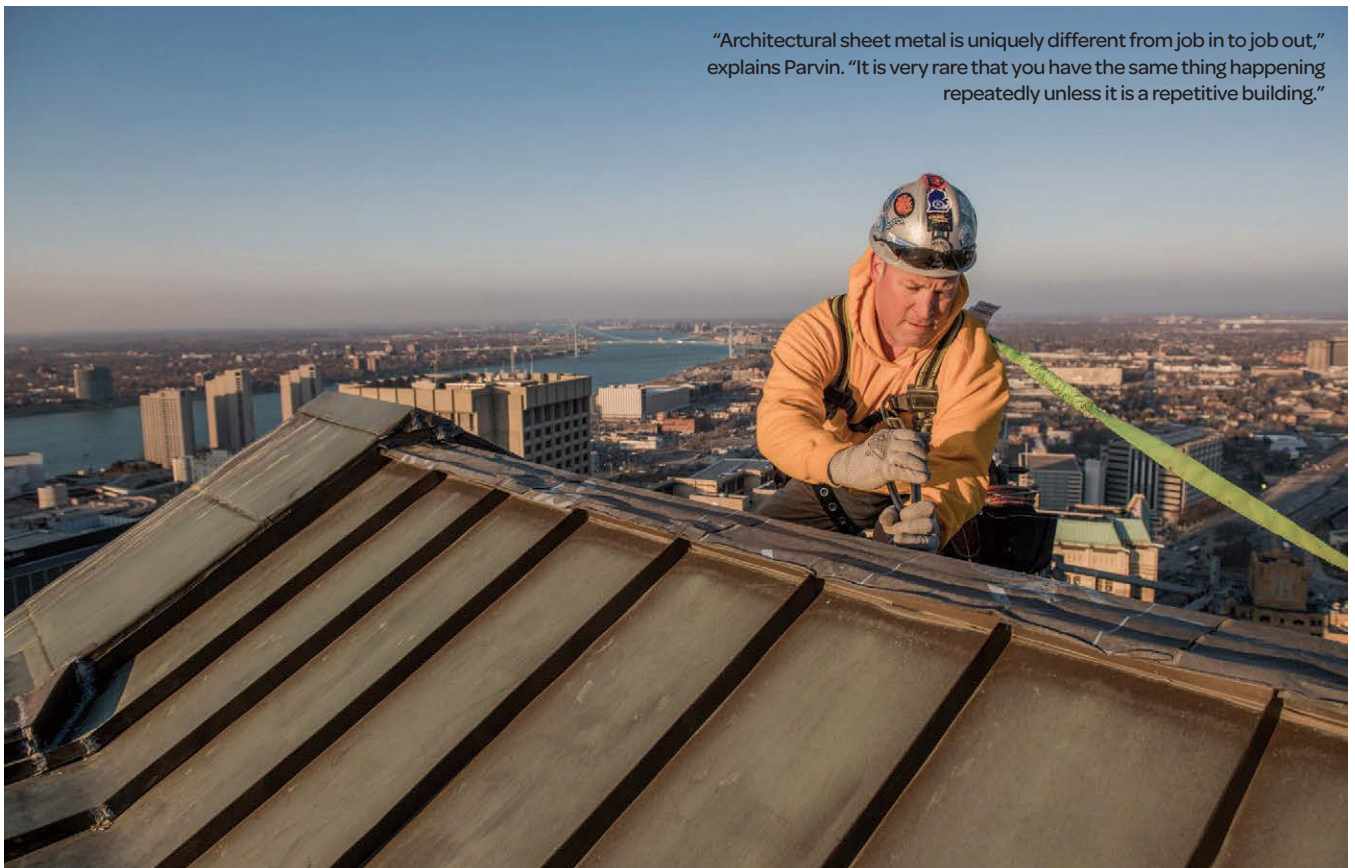
“We had to figure out how to get to places,” explains Cass Sheet Metal president and owner Glenn Parvin. “We’re working off of 40-foot ladders, coming out of a large five-foot wide gutter, 500 feet in the air to repair various aspects of the Tower.” Photo by Josh Scott.

“We estimated 40 different line items of new copperwork, copper repairs on certain items, copper repairs around the building,” explains Parvin. “We had to figure out how to get to places ... We’re working off of 40-foot ladders, coming out of a large five-foot wide gutter, 500 feet in the air to repair various aspects of the Tower.”

“All built-in gutters up top were replaced, tying them into the batten seam roof. They wanted to save as much of the batten seam roof as they could,” Parvin says. “The copper on the dormers was laden with mastic asphalt. There are six dormers on the tower so all the copper dormer work has been redone. And that’s been part of the changes and additions of our scope. We had a scope, but

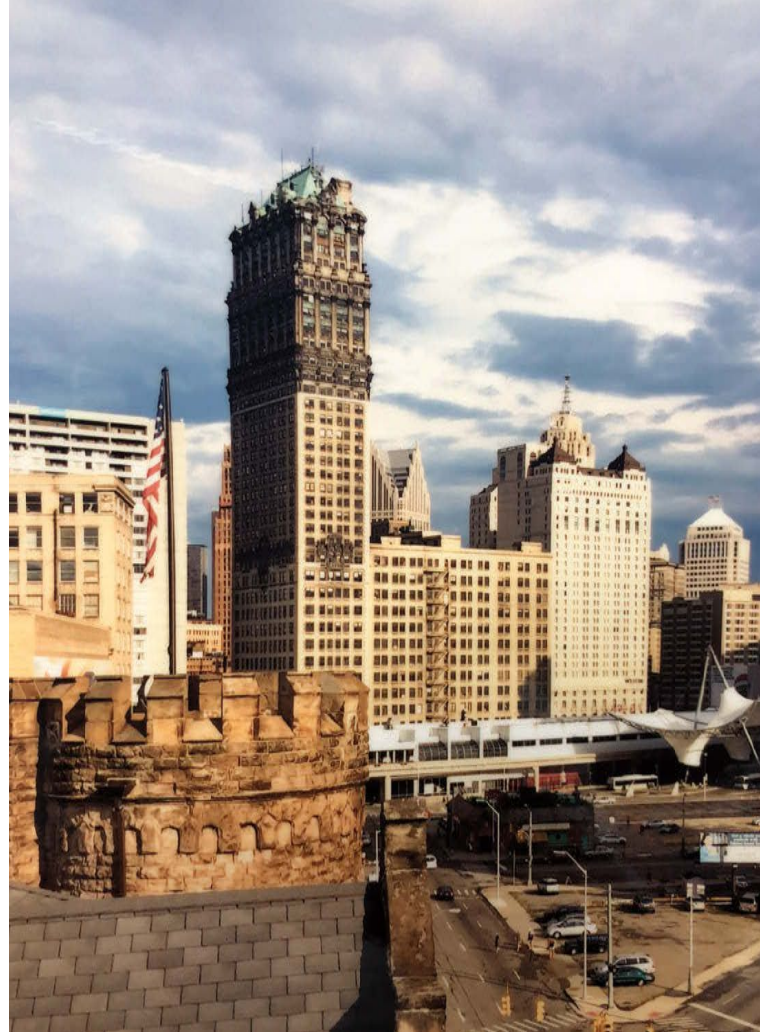
From this view, the Book Tower’s green copper roof is unmistakable.

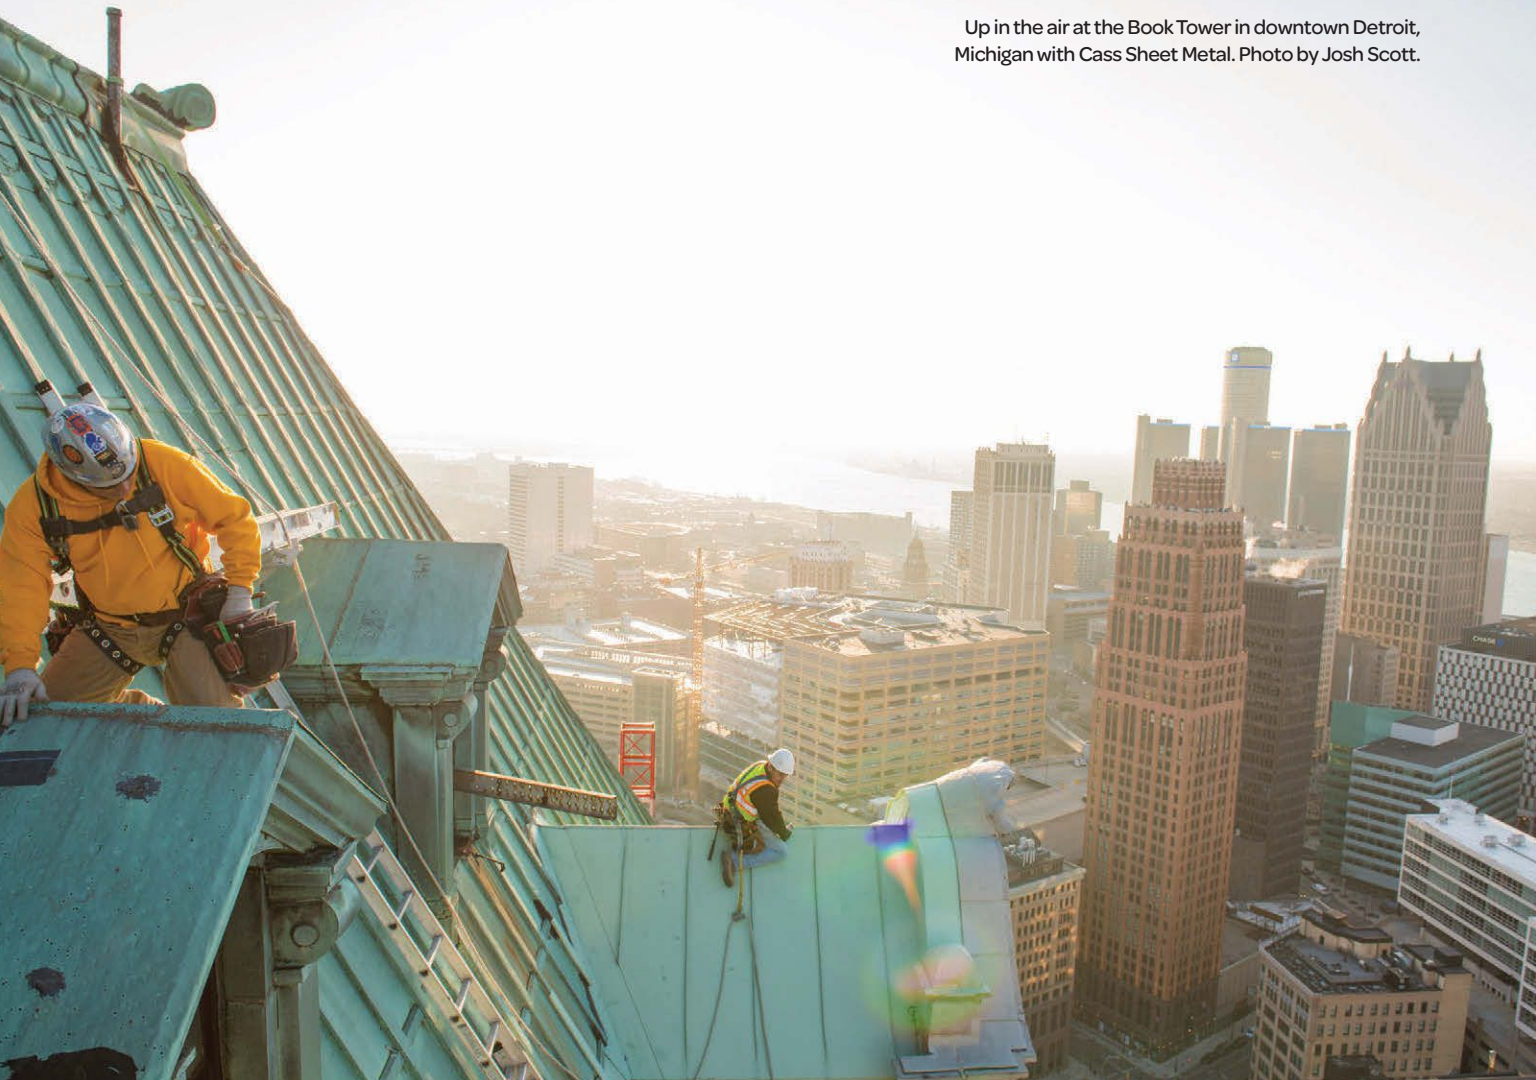
Up in the air at the Book Tower in downtown Detroit, Michigan with Cass Sheet Metal. Photo by Josh Scott.

Overall, Cass Sheet metal replaced windowsills on many floors with copper, bullnose fabricated components, a lot of custom fascia panels on floors 35 and 36 and custom stamping replication.
